# **DIGITAL TWIN: MURALLA DE AVILA AND ESCUELAS MAYORES OF THE UNIVERSITY OF SALAMANCA**

***“Good practices of digitization of natural and Cultural Heritage as anti pandemic measures (Spain)”***

**Name: Diego Gonzalez-Aguilera**  
**Position: Full Professor, Engineering**  
**Institution: University of Salamanca, EPS Avila**

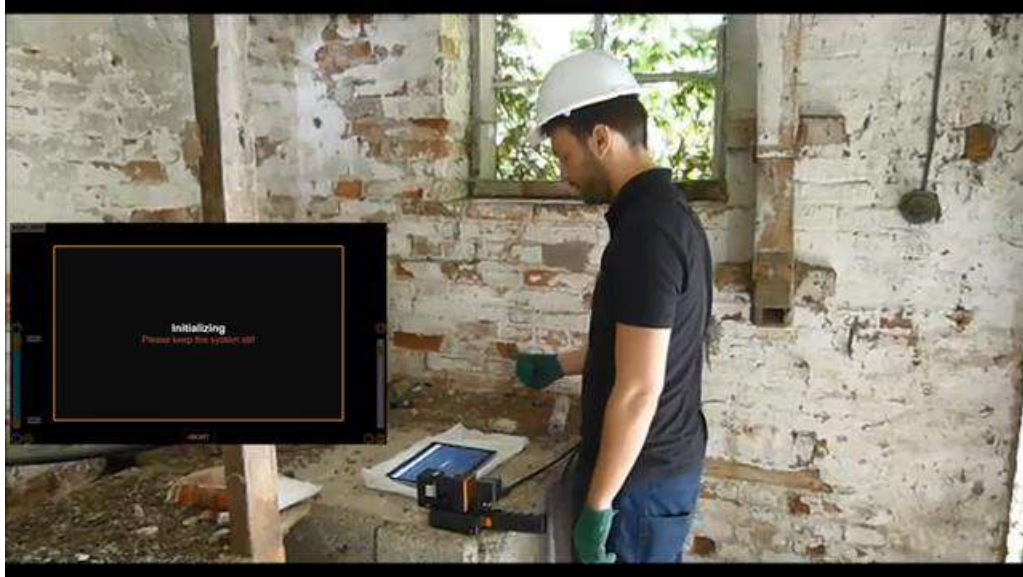
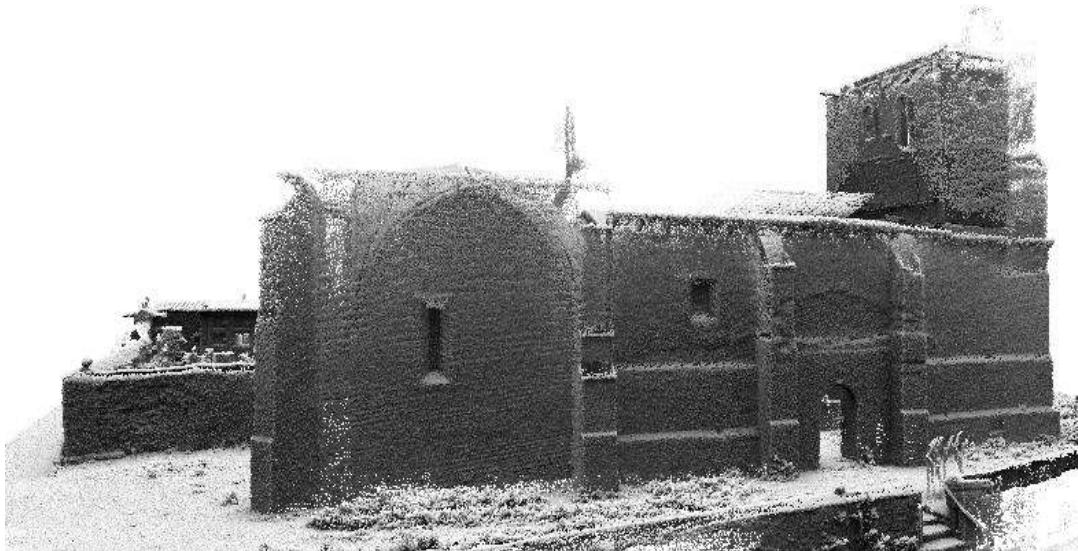
- ✓ Intuitive
- ✓ Low-Cost and easy to implement
- ✓ Metric properties (1-2 cm accuracy)
- ✓ More efficient than laser or photogrammetric techniques
- ✓ Ideal for complex Cultural Heritage scenarios

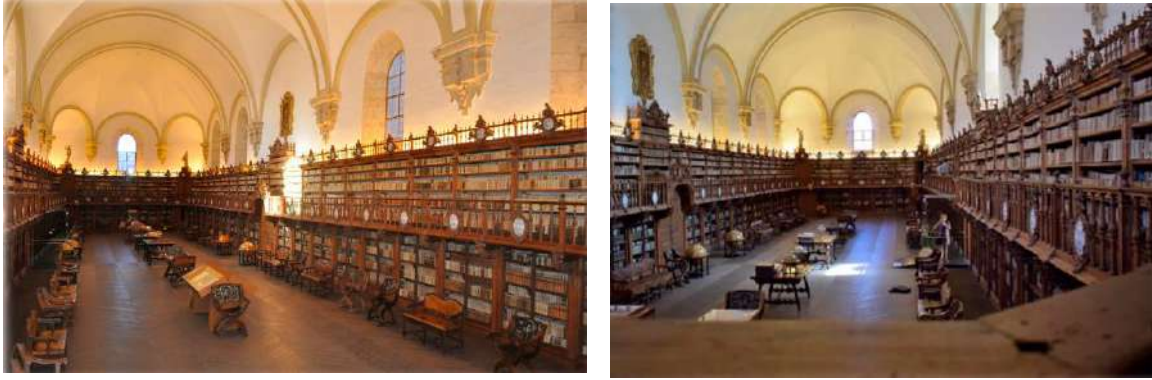
- ✓ Dynamic capabilities
- ✓ Low-Cost and easy to implement
- ✓ BigData performance and BigData analytics
- ✓ Great variability of sensors and parameters
- ✓ LoRaWAN network

- Moisture
- Temperature
- Luminosity
- Inclination
- Fissures
- Etc.

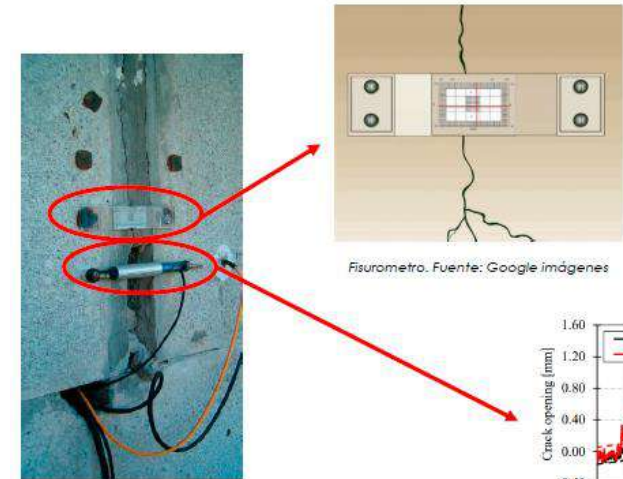
Fisrometro. Fuente: Google imágenes

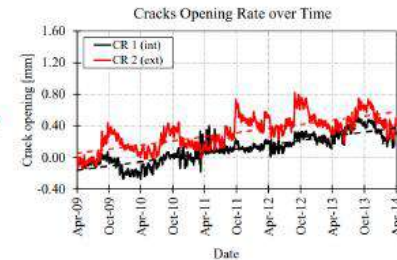
Fisrometro y LVDT. Fuente: Puliga, 2014

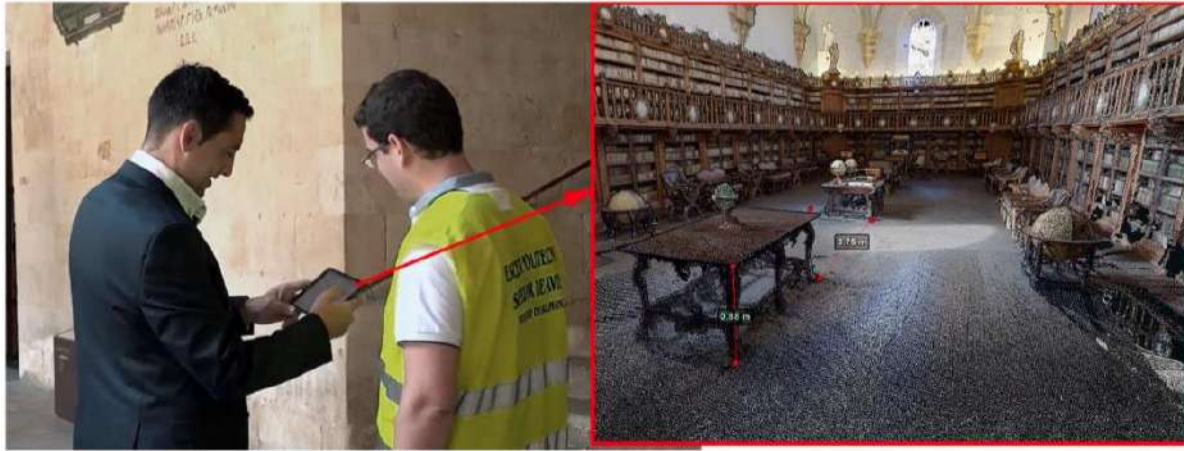
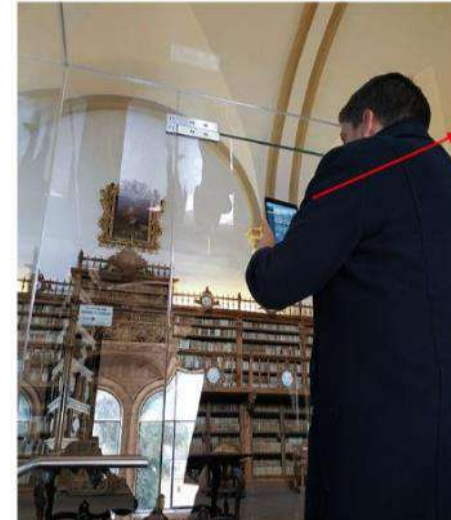
Class No.	Condition Classification	Symptoms	Urgency Risk Classification	Comments
0	Good	No symptoms	Long term	No immediate actions required   Preventive monitoring is necessary
1	Fair	Minor Symptoms	Medium term	The condition of the fabric is not perfect but does not need immediate action   Monitoring is necessary to prevent further decay
2	Poor	Moderately Strong Symptoms	Short term	The condition of the fabric is such that it needs timely repair or additional inspection and diagnosis work
3	Bad	Major Symptoms	Urgent and Immediate	Urgent repair is necessary   Urgent additional inspection and diagnosis work
NA/NI	Not Accessible	Parts not (safely) accessible	Not Inspected	Parts that are 'not inspected' are either not (safely) accessible for the building inspectors or not visible

Masonry Wall	
<b>Damage 1</b>	
Damage Class	Biological Colonization
Damage Sub Class	Beams and floors
Damage Sub Sub Class	Moist Area
Condition Classification	Poor
Symptoms	Moderately Strong Sym...
Condition Grade	In poor condition
Description	Se detectan valores d...
Location	Planta Baja
<b>Damage 2</b>	
Damage Class	Crack
Damage Sub Class	Columns and Walls
Damage Sub Sub Class	Broken Elements
Condition Classification	Fair
Symptoms	Minor Symptoms
Condition Grade	In fair condition
Description	Se detectan valores d...

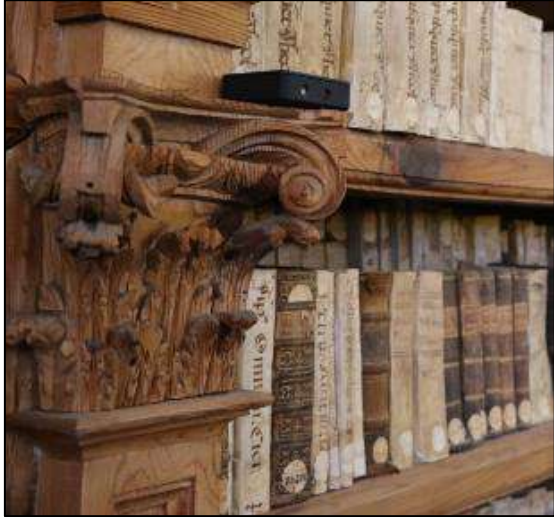
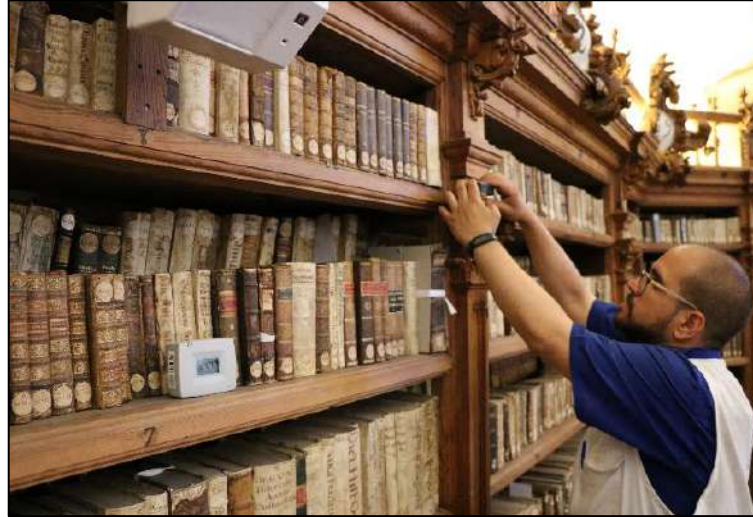
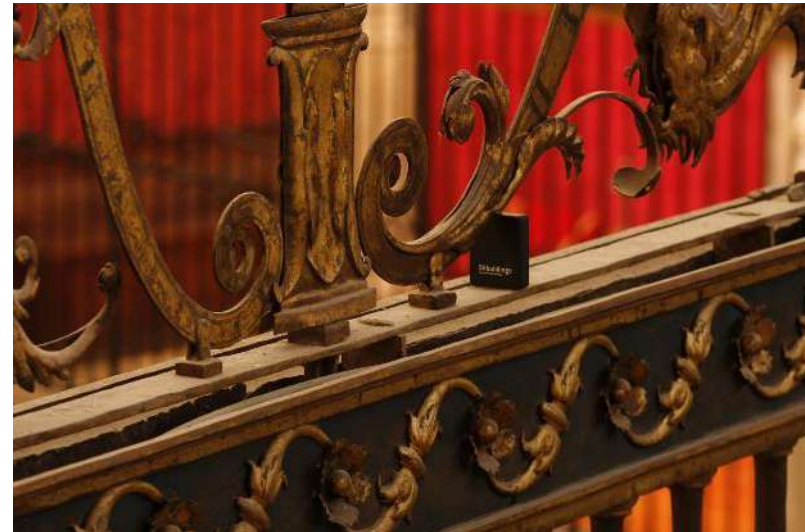
# MONITORING WITH IoT SENSORS

Masonry Wall	
<b>Damage 1</b>	
Damage Class	Biological Colonization
Damage Sub Class	Beams and floors
Damage Sub Sub Class	Moist Area
Condition Classification	<b>Poor</b>
Symptoms	Moderately Strong Sym...
Condition Grade	In poor condition
Description	Se detectan valores d...
Location	Planta Baja
<b>Damage 2</b>	
Damage Class	Crack
Damage Sub Class	Columns and Walls
Damage Sub Sub Class	Broken Elements
Condition Classification	<b>Fair</b>
Symptoms	Minor Symptoms
Condition Grade	In fair condition
Description	Se detectan valores d...

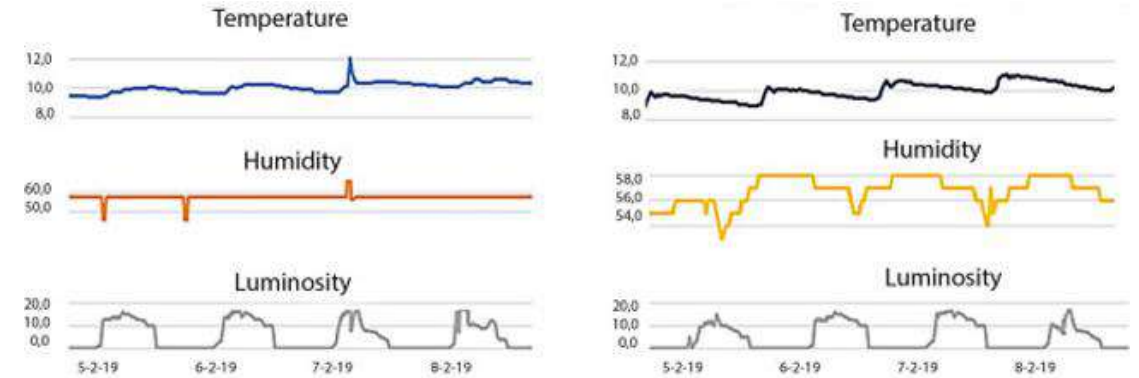
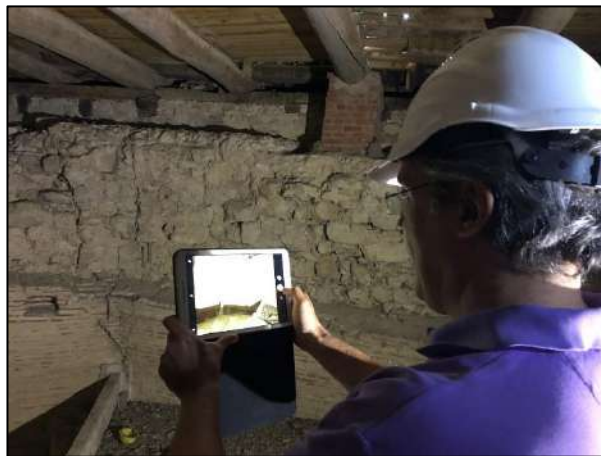
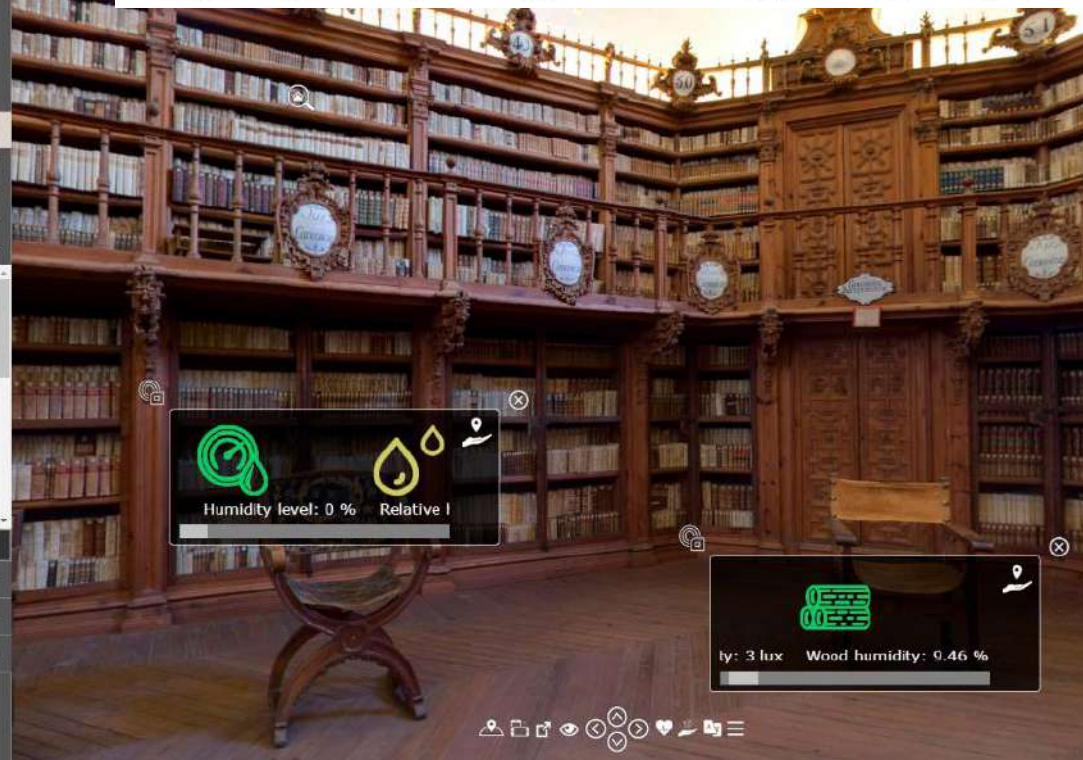
## INSPECTION LEVEL (PREVENTION)

- ✓ Monitoring
- ✓ 2D and 3D inspection
- ✓ Virtual environment
- ✓ Best practices

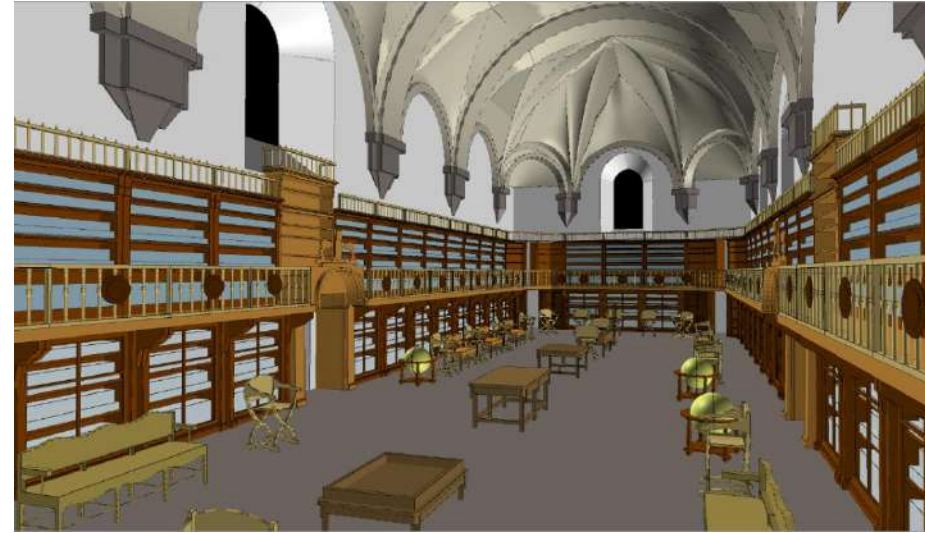
## SIMULATION LEVEL (PREDICTION)

- ✓ Risk mapping
- ✓ 4D analysis
- ✓ FEM & HBIM
- ✓ Support Decision Taking
