## IN-SITE ANALYSIS

<p><b>Name of the Fortress, Location</b></p>	<p>Wall of Albarracín, Teruel, Spain</p>
<p><b>Historical background</b></p>	<p>Albarracín (Teruel, Spain), an Aragonese city with an imposing medieval legacy, witnessed by its architecture and urban planning. It became a Taifa kingdom and an independent lordship. Its defensive needs forced it to close in on itself and to have narrow streets, with hardly any squares or free spaces. The typical reddish farmhouse is perched on a limestone cliff carved by the Guadalaviar River and surrounded by the wall, from which the castle and the cathedral emerge as the most unique pieces.</p> <p>Around the year 965, a first defensive enclosure was built, protected by twelve towers and which included the fortress, an albarrana tower (Torre del Andador) and an entrance gate (Portal de Hierro). In the S. XI, coinciding with the conversion of Albarracín into the capital of the Taifa, the enclosure is extended to include the Torre del Andador and three portals and a new albarrana tower (Torre de la Muela), now disappeared, are incorporated. Between the 13th and 14th centuries, with the city already in Christian hands, the White Tower wa

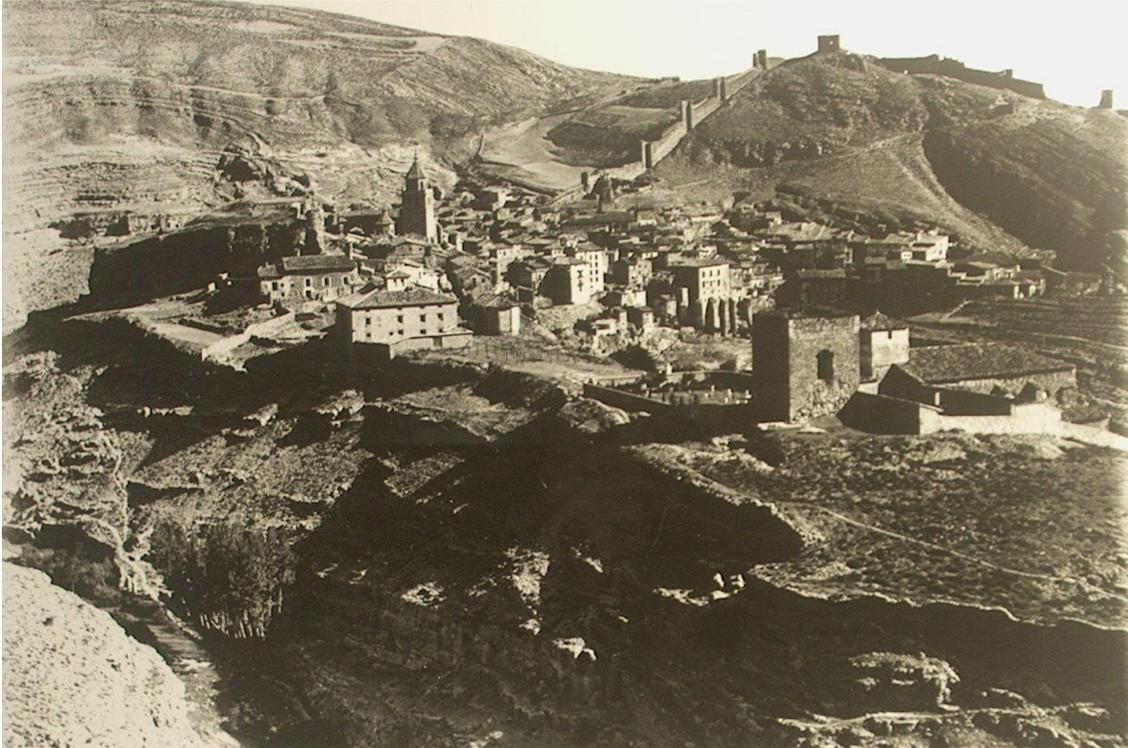
Figure 1. Image of the walled enclosure of Albarracín in 1952, before the first restoration works. Photograph from the archive of Francisco López Segura. Institute of Teruel Studies. Reg. No. 157.

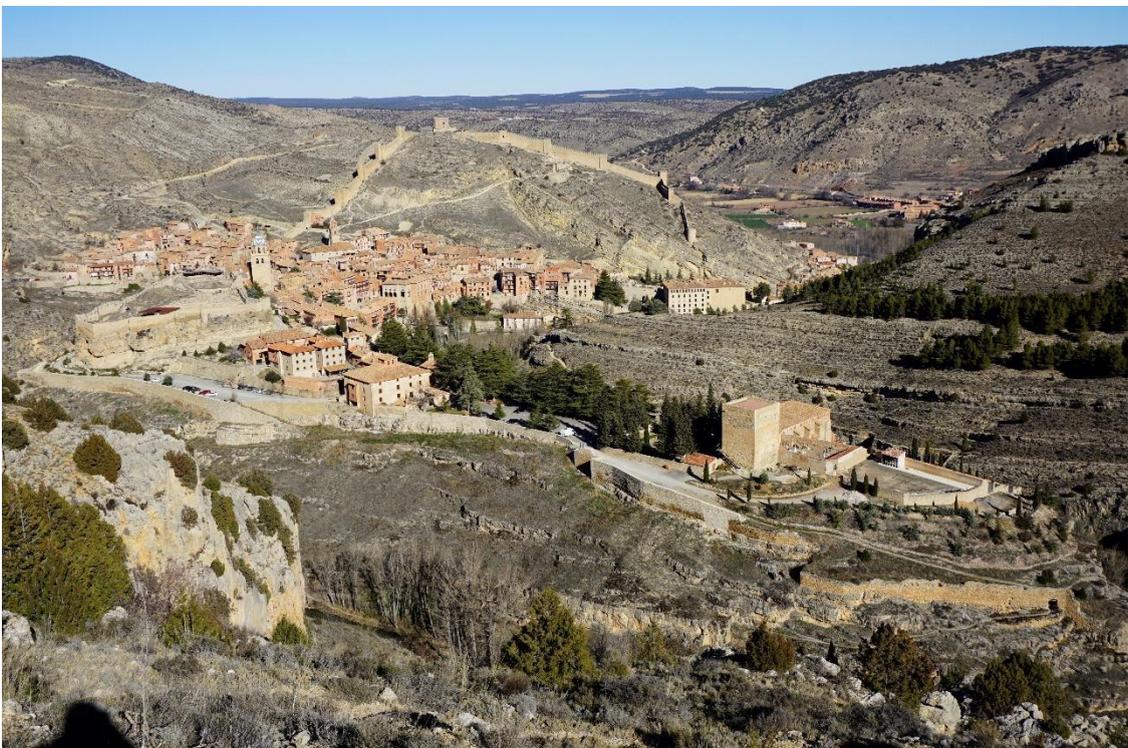
Figure 2. Image of the walled enclosure of Albarracín in 2019, before the restoration of the southern wall.

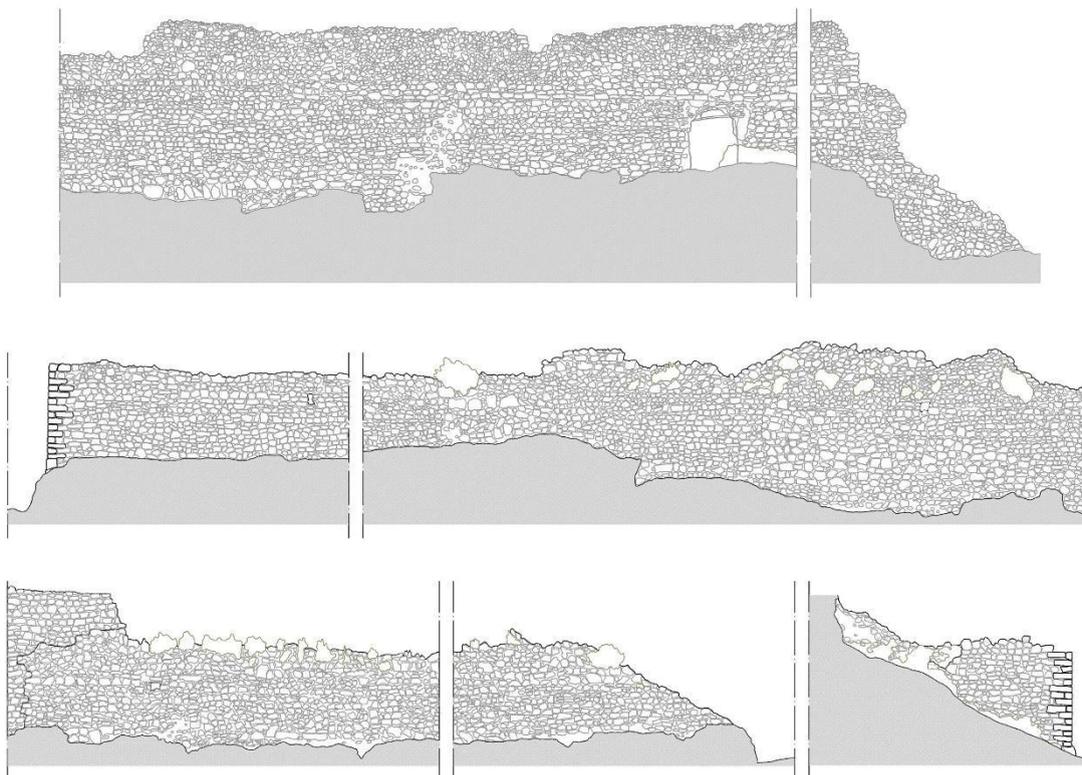
Figure 3. Survey of the previous state of the wall sections included in the project under development

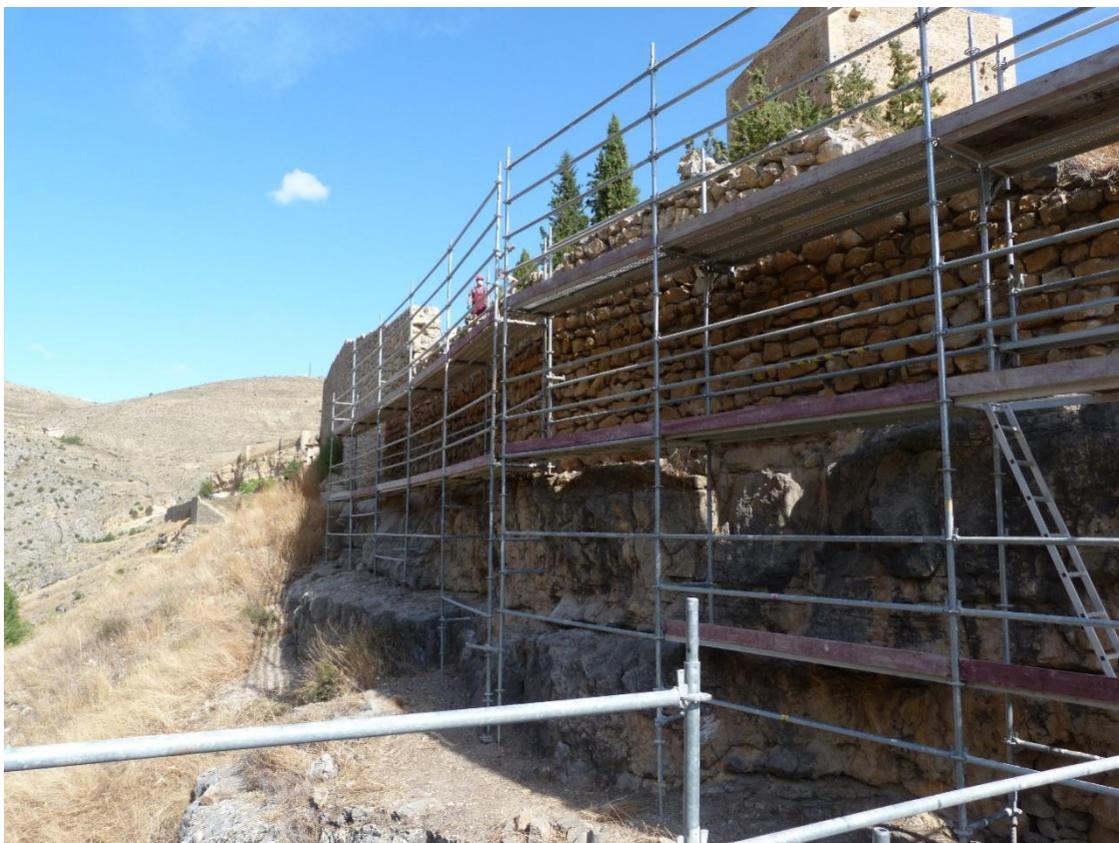
Figure 4. First restoration work on the south

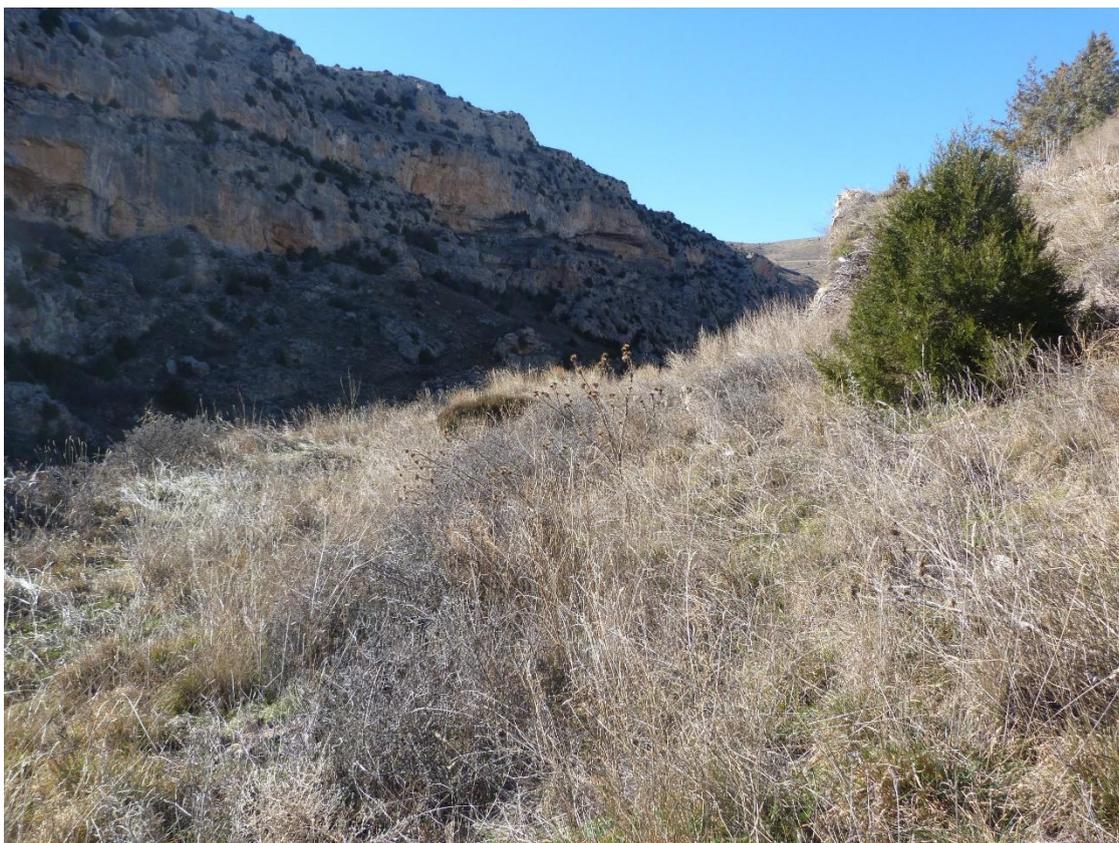
Figure 5. Intrados of the south wall in 2019, completely amortized by the land

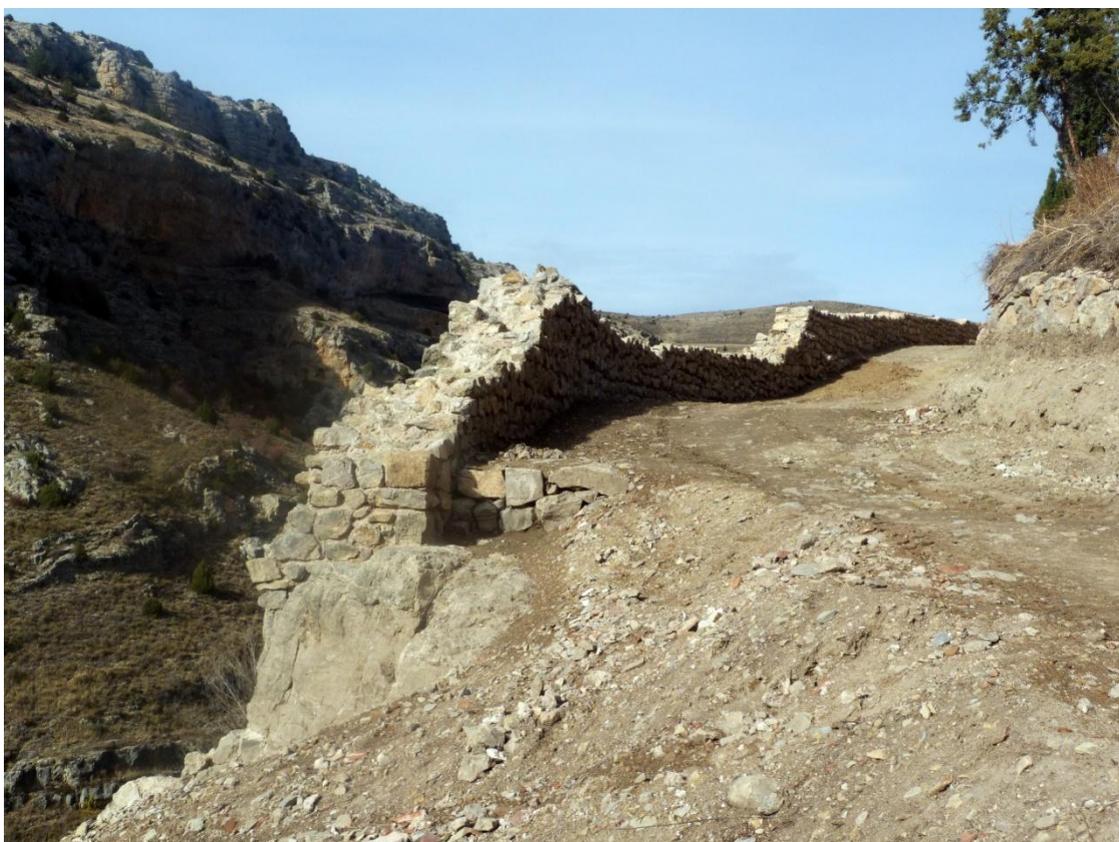
Figure 6. Recovery of the intrados of the wall section intervened in the first phase (2020)

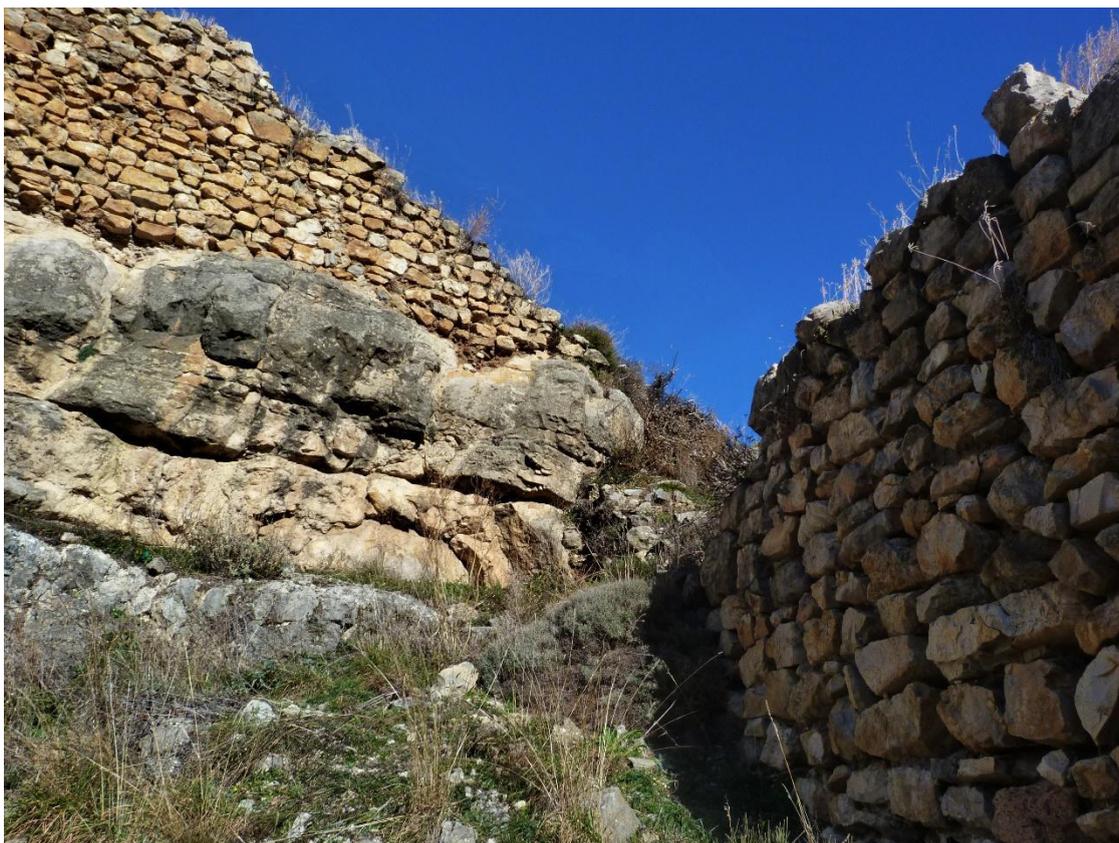
Figure 7. Extrados of the south wall in 2019

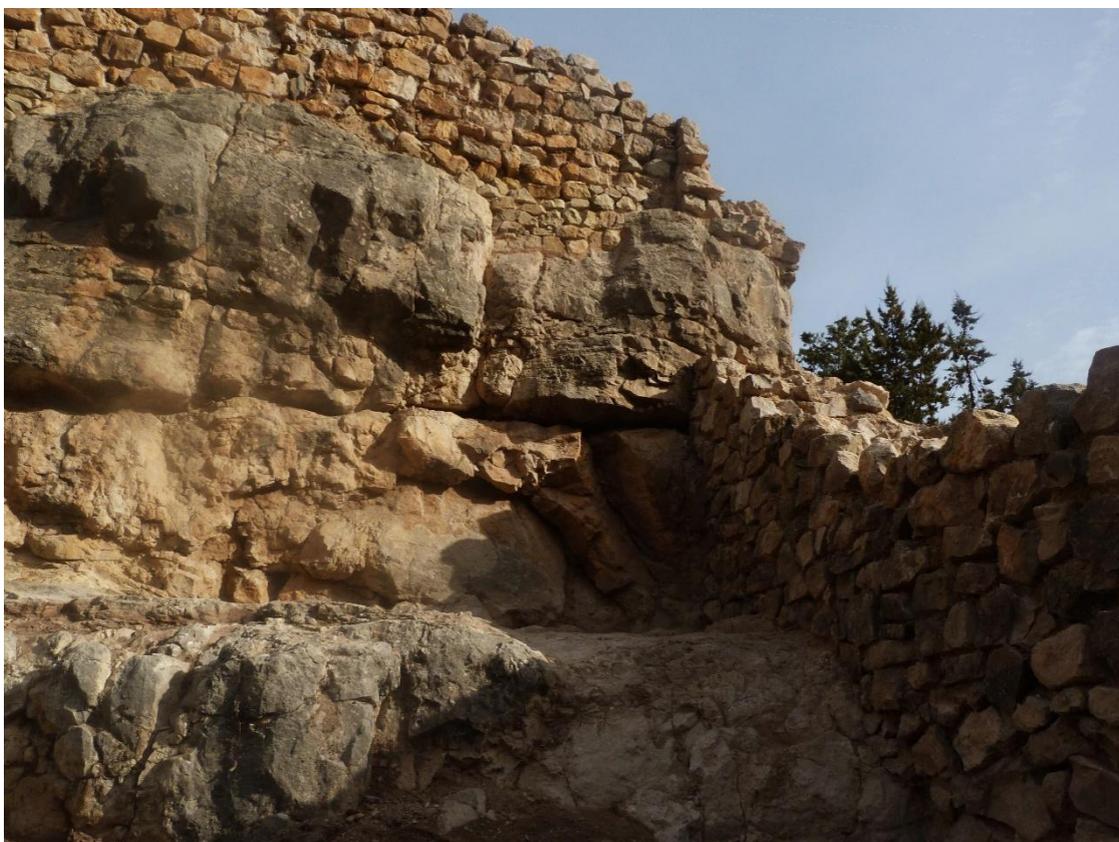
Figure 8. Recovery of the extrados of the wall section intervened in the first phase (2020)

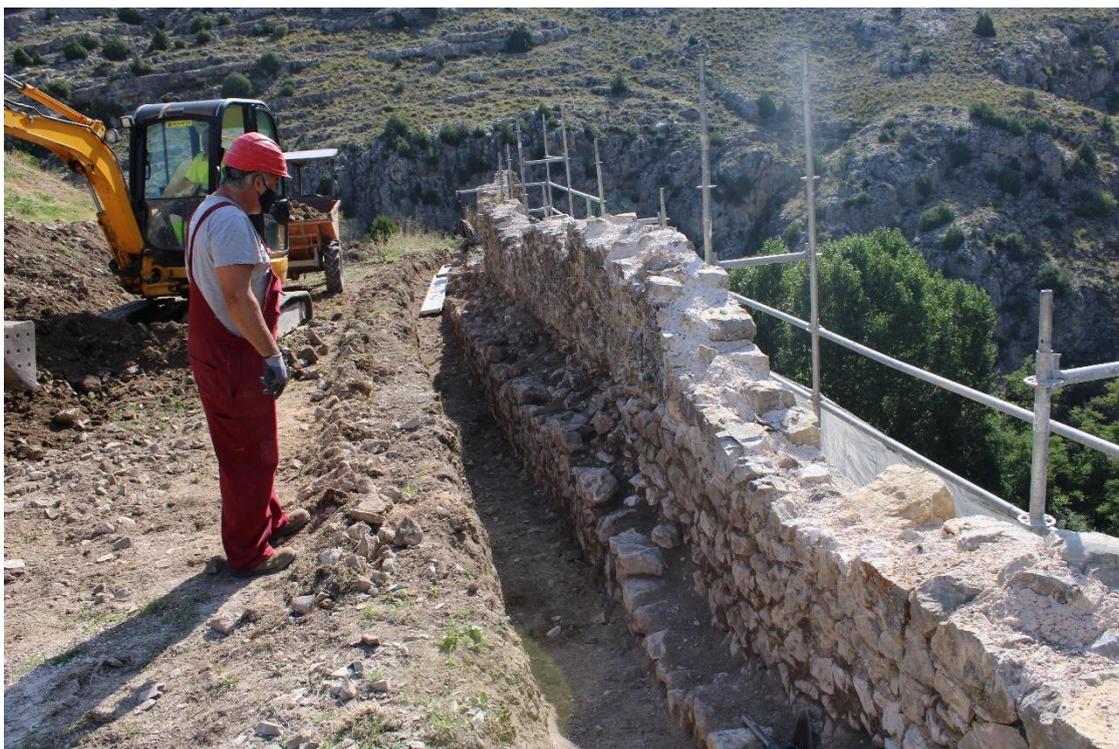
Figure 9. Excavation of the intrados of the wall section intervened in the second phase (2021)

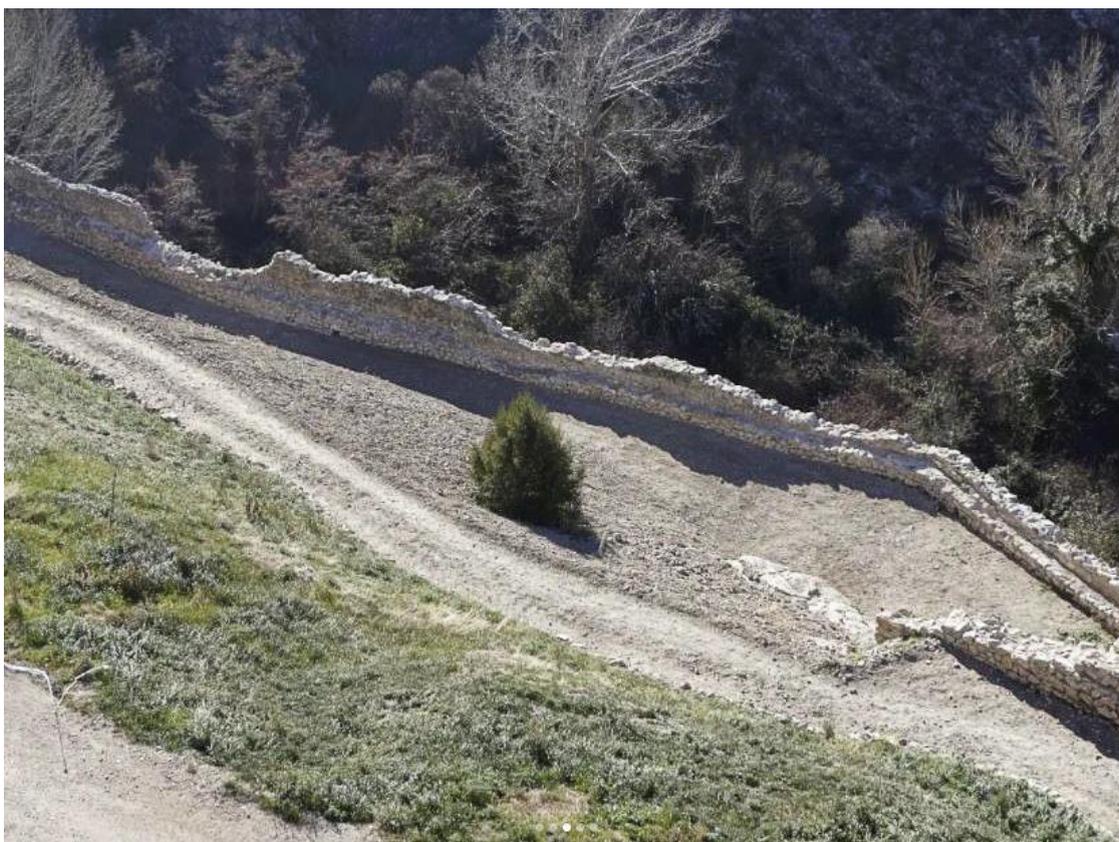
Figure 10. Recovery of the historical levels in the intrados of the wall section intervened in the second phase (2021)
